**WALDRICH BLEACHERY**

**DAM**

**PHASE I INSPECTION REPORT**

**NATIONAL DAM SAFETY PROGRAM**

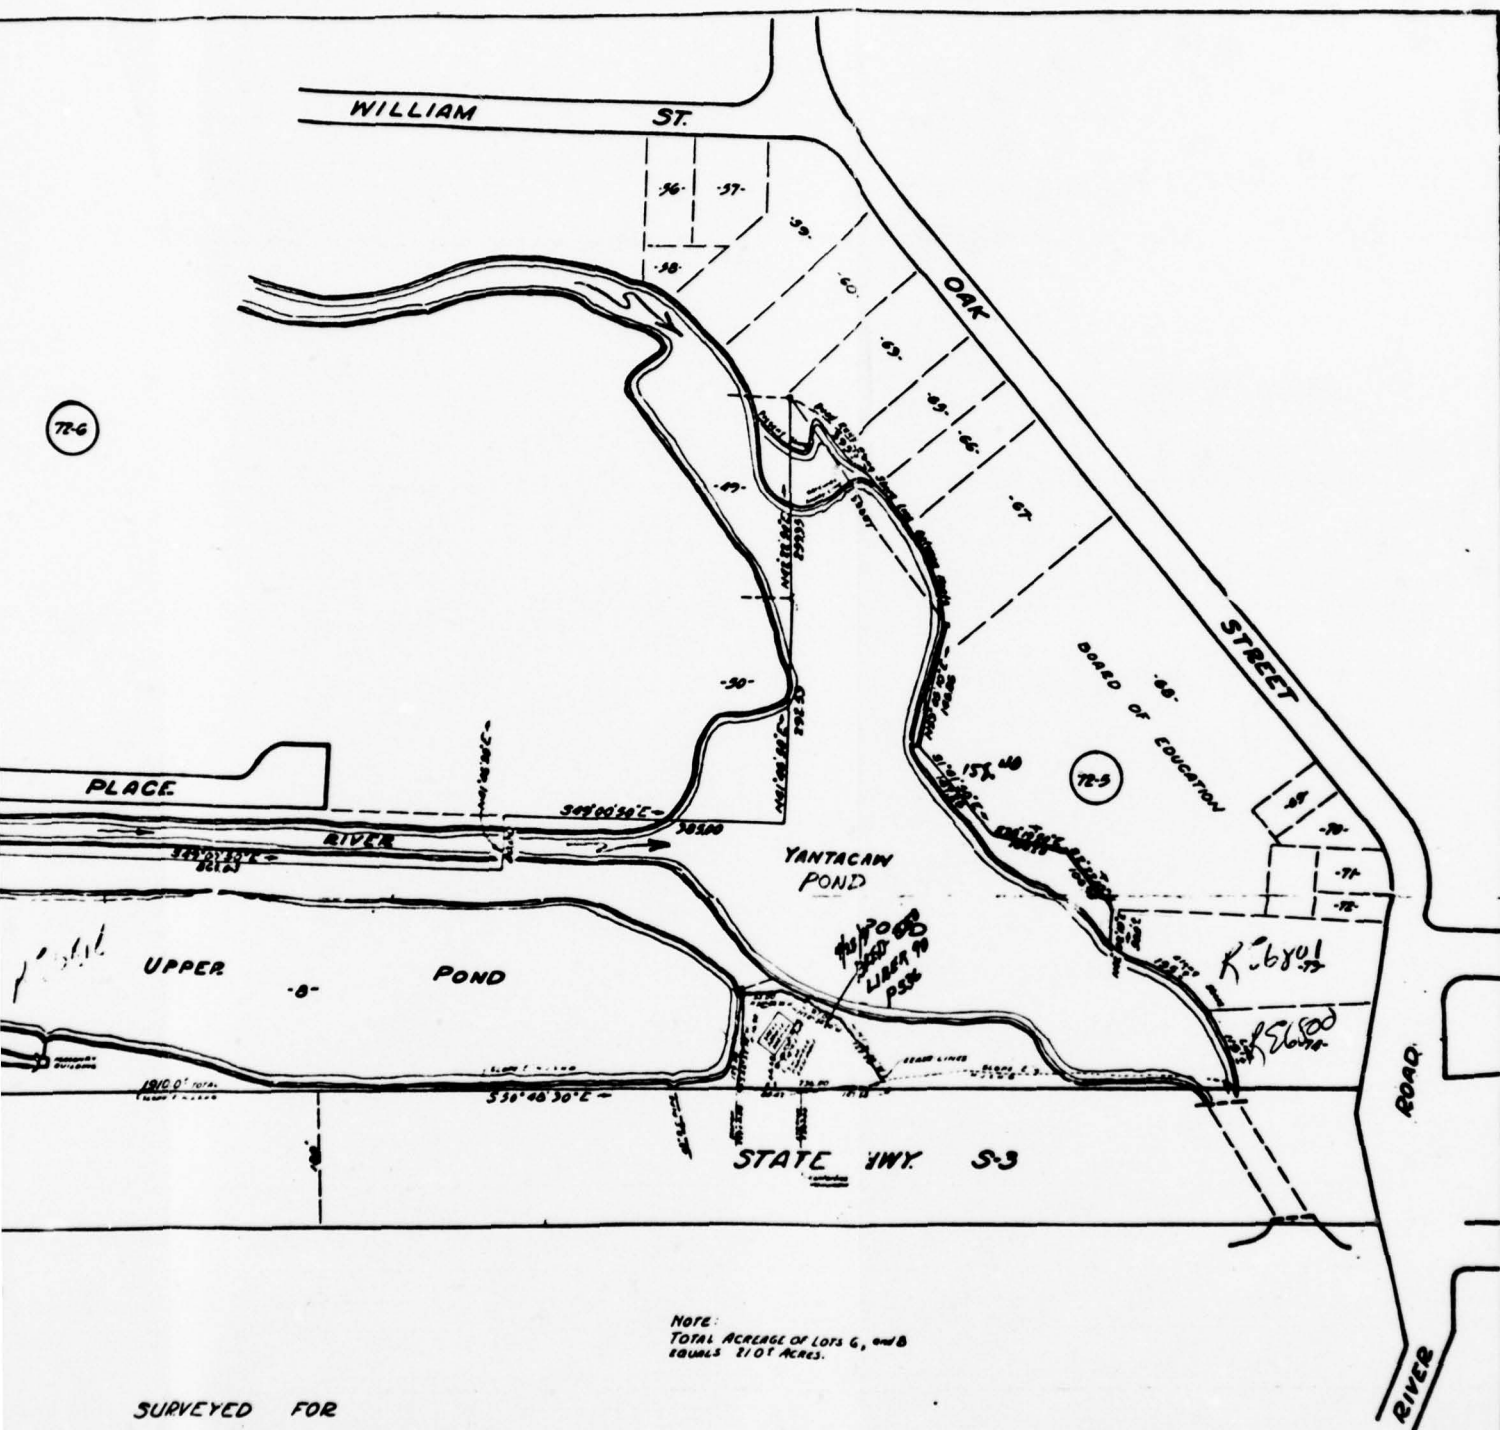
A slight restriction in this downstream channel was observed under River Road Bridge where an accumulation of boulders and cobble are present against the east abutment. The restriction has the effect of increasing the elevation of the tailwater below the dam. The higher tailwater could have the effect of decreasing the spillway capacity below the dam, with the result of more water overtopping the dam and River Road.

Boulder & Cobble Deposit  
Restricting Stream Channel

Additionally, it is recommended that a boulder deposit under River Road Bridge and a small severely leaning retaining wall constructed in the stream channel downstream from the bridge should be removed since they restrict flood flows. However, removal of these restrictions is not the responsibility of the dam owner.

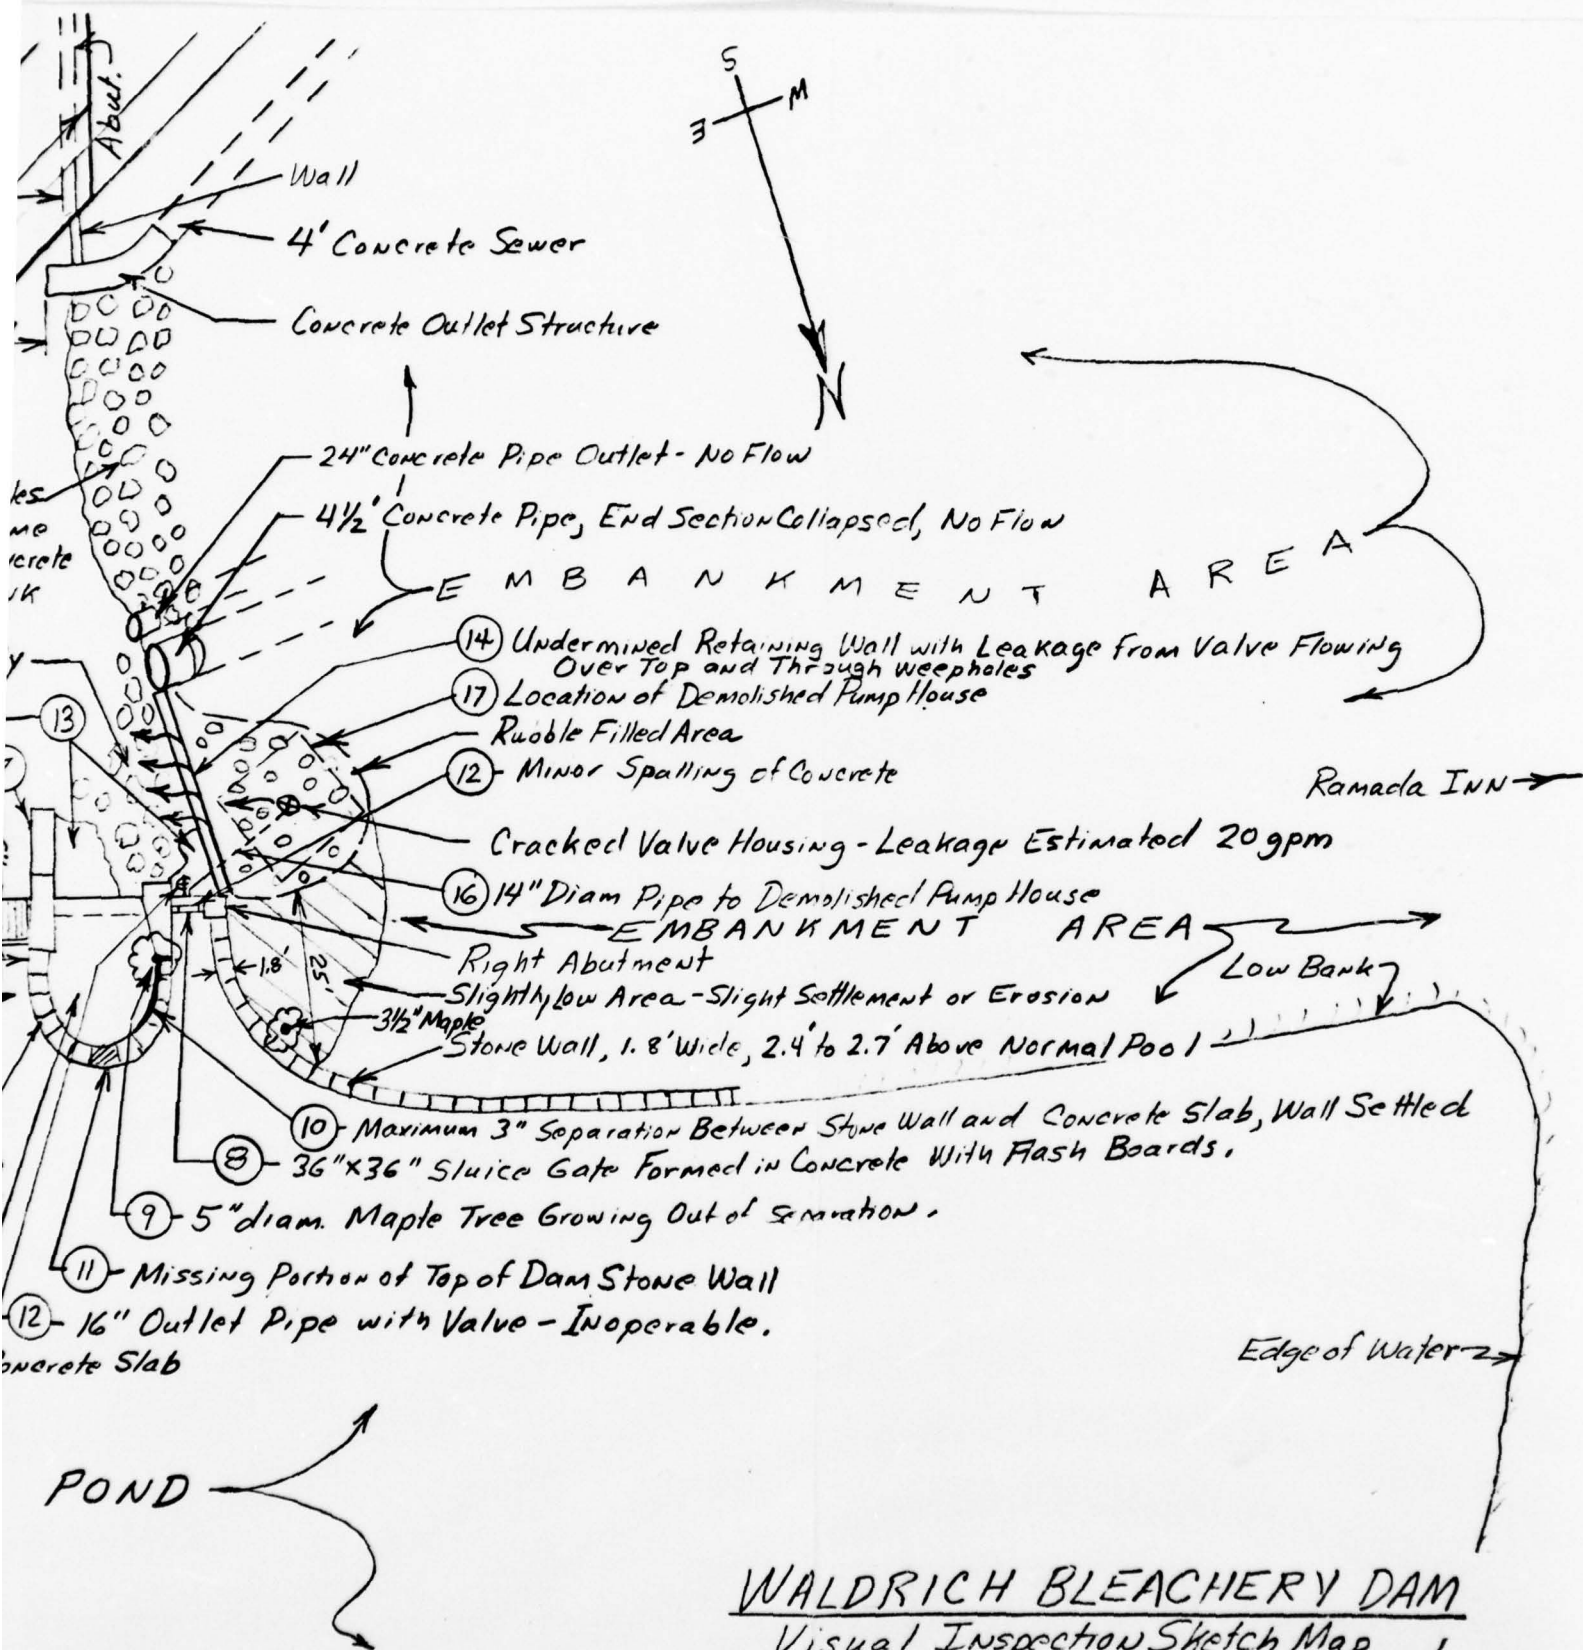
## WALDRICH BLEACHERY DAM

The retaining wall (2) between the left dam abutment and River Road Bridge abutment was observed to be seriously undermined up to 44 inches under the foundation near the spillway. This wall, otherwise, appears to be in good condition.

The masonry and timber spillway was observed to have a course of stone blocks (1.5 feet high and 8.7 feet in length) missing (4) just above the level of the tailwater, 40 feet from the left abutment. The course of stone blocks above appeared to be working loose.

Twenty feet from the left abutment, part of a course of stone blocks, 2.5 feet in length, is also missing (5) from the spillway just above tailwater elevation. Evidence of mortar deterioration is present in courses of stone block adjacent to those areas where the blocks are missing.

The downstream end of the concrete buttress wall (7) at the right end of the spillway is founded on the remains of a seven inch concrete slab which had formed an apron. The undermining extends under the downstream corner of the buttress. The buttress wall is cracked at the top with a crack width of one-sixteenth to one-eighth of an inch. The crack extends across the top of the adjacent concrete slab overlying the central part of the concrete and masonry section of the dam. Minor spalling of the buttress adjacent to the spillway was observed.

There is a six feet wide concrete section (8) adjacent to the left side of the 36 inch square sluice gate that is spalled on the front face and on the area adjacent to the sluice gate.

Adjacent to the 36 inch square sluice gate (12), there is some minor spalling of concrete.

Adjacent to the originally constructed apron along the right bank of the stream channel from the right abutment extending 30 feet downstream exists a concrete wall (14). This wall was observed to be undermined by scour over a distance of more than 15 feet. The undermining extends back under the retaining wall a distance of up to 54 inches at one point. The retaining wall is functioning, in essence, as a cantilevered section and may collapse at any time. A 16 inch diameter outlet pipe (15) was observed below the 36 inch square sluice gate near the right abutment. The pipe had previously been used to draw water from Yantacaw Pond and from an adjacent pond located to the west (see Plate 2); which is now reportedly being filled in for land development according to Mr. Valenstein of Chase Manhattan Bank. At the time of the inspection, the pipe outlet was not functional.

A 14 inch diameter pipe (16) is located just above the 16 inch outlet pipe. The pipe flows from the pond to the recently demolished pump house (17), also shown on Plate 1. When the pump house was demolished, the basement was filled with rubble, cracking a valve housing on the pipe causing leakage. The leakage, estimated at 20 g.p.m., flows through the rubble and fill material, and then over and through weep holes of the undermined concrete wall described as item (14) above.

The surface of the earth embankment adjacent to the right abutment shown on Plate 3 was observed to be a few inches lower than the adjacent stone wall. This area of the embankment is probably low due to settlement; or, more likely, erosion from overtopping of the dam 8 November 1977. The sandy soils forming the embankment at this location are considered to be highly erodible.

Visual Inspection Sketch Map  
 Showing Conditions 20 June 1978  
 Drawn by JRR - Michael Baker Jr. Inc.

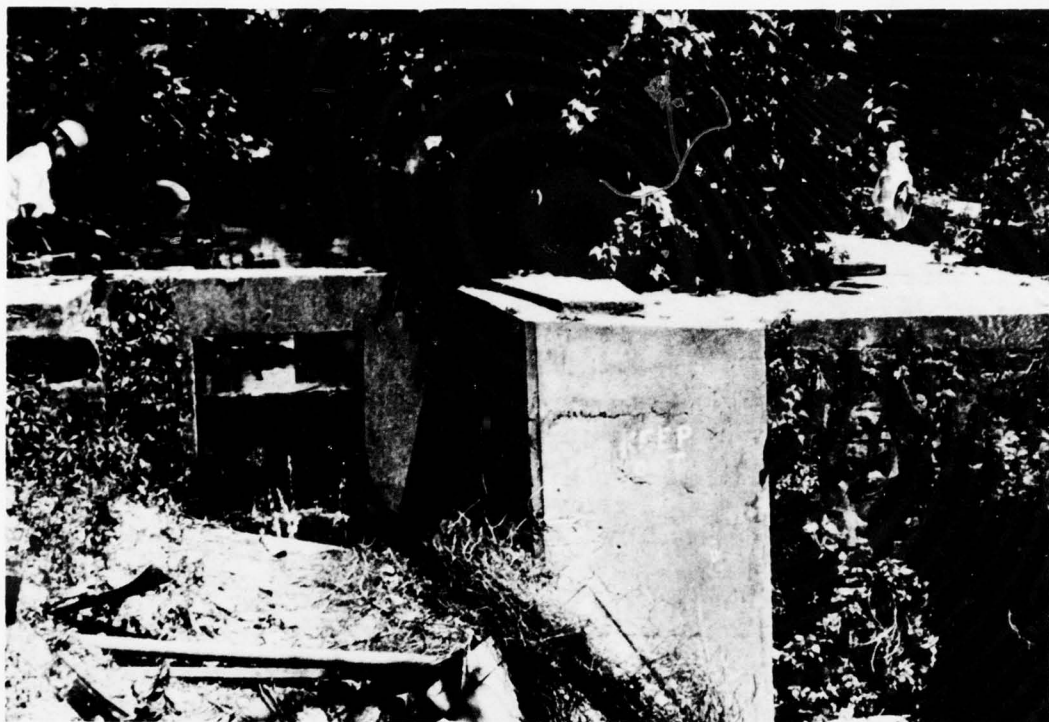
PHOTO 3

Photo 3 - Right Abutment Area (Picture Shows Rubble Fill in Foreground, Trees Growing in Cracks in Concrete and Rectangular Gate With Water Seeping Through Flashboard.) - 20 June 1978.

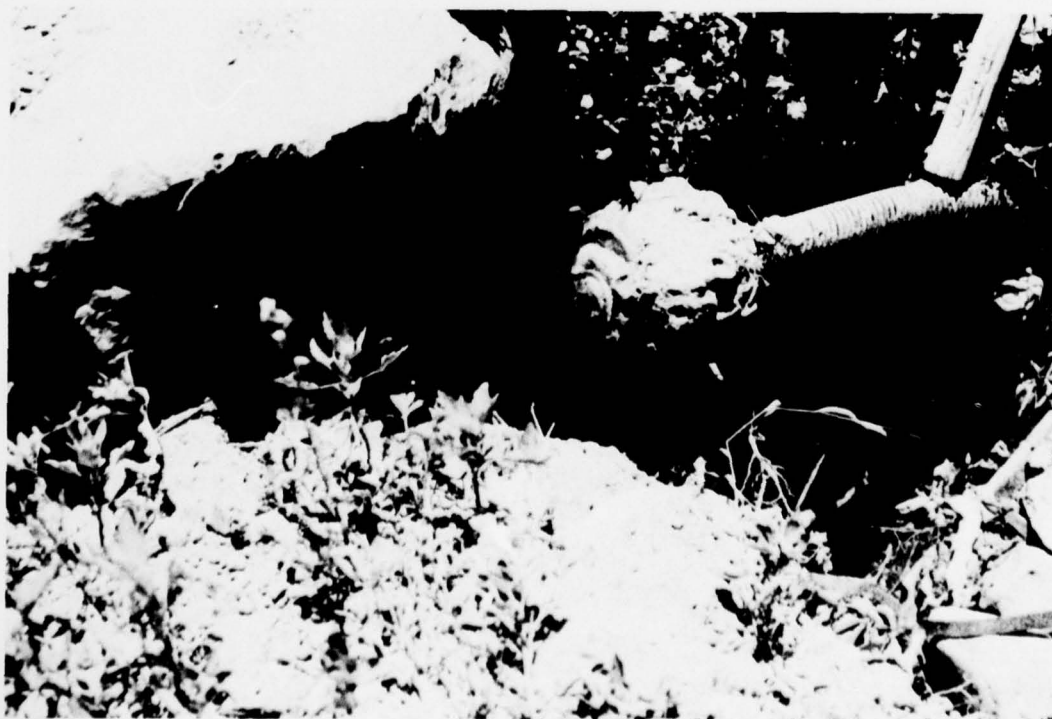
PHOTO 6

Photo 6 - Top of Valve on 14 Inch Pipe in Pump House (Area Is Shown in Right Side of Picture Under Threaded Rod. Dumping of Rubble Cracked Valve Housing Causing Leakage Which Flows Through Rubble and Then Over and Through Weep Holes of Undermined Retaining Wall in Photo 4) - 20 June 1978.

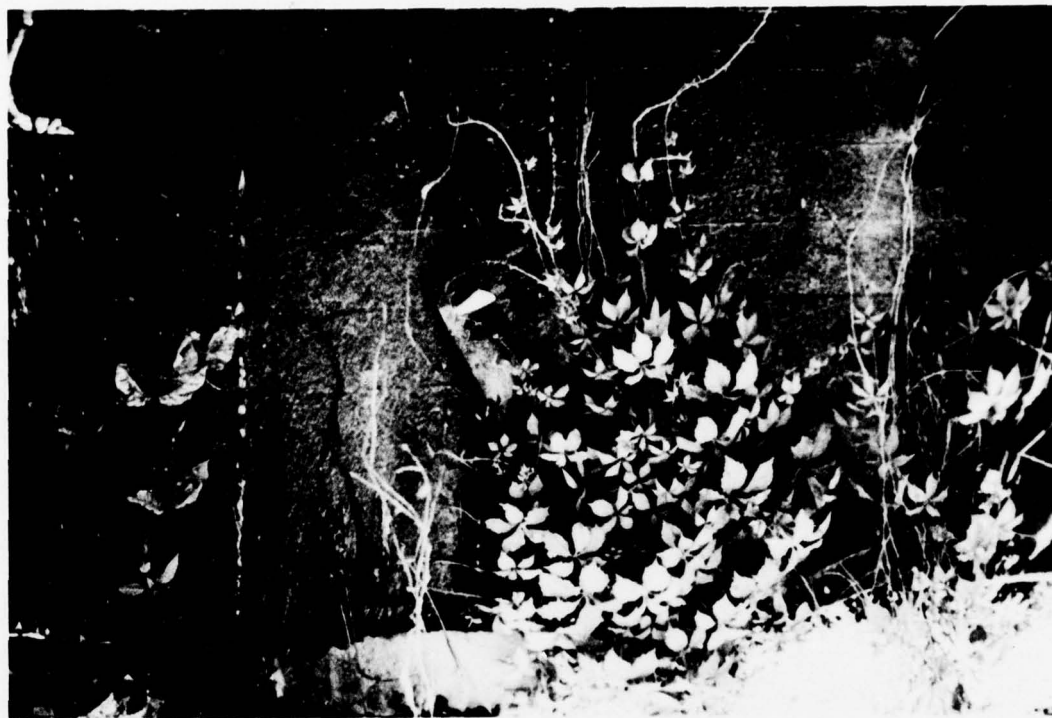
PHOTO 7

Photo 7 - Close-Up of Leakage From Pipe Valve Flowing Over Retaining Wall - 20 June 1978.

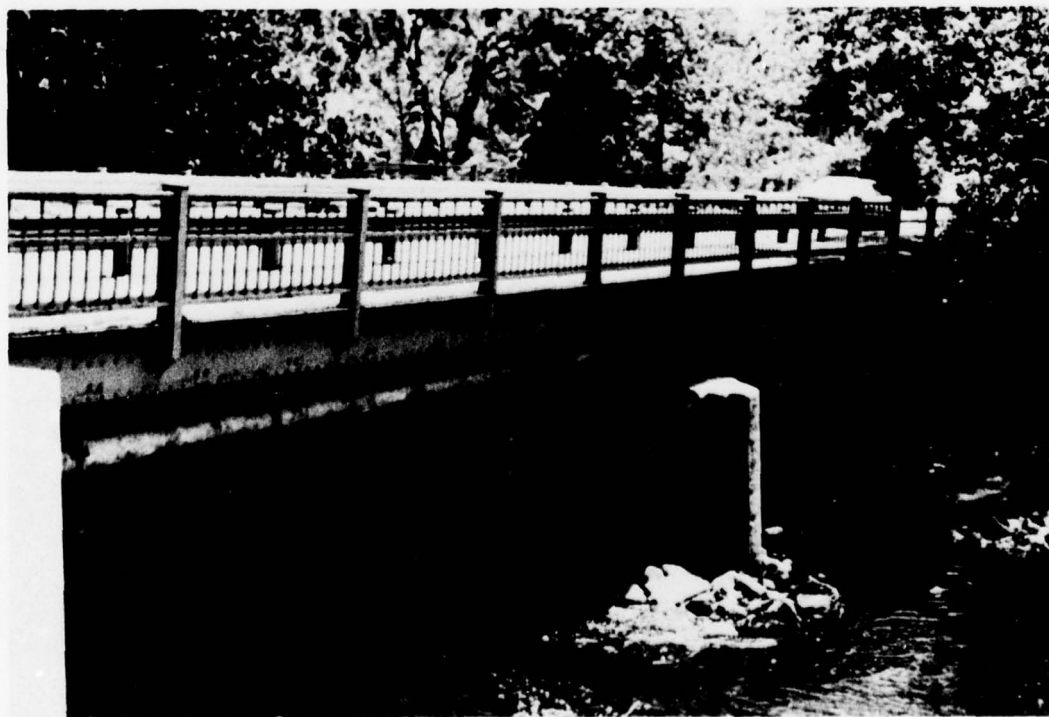
PHOTO 8

Photo 8 - View of River Road Bridge and Storm Sewer Concrete Outlet at Right of Photo (Flood Conditions on 8 November 1977 Overtopped Bridge Deck) - 20 June 1978.
